RC
1042
.M38
1990a
c.2

Department
of Transportation
National Highway
Traffic Safety
Administration

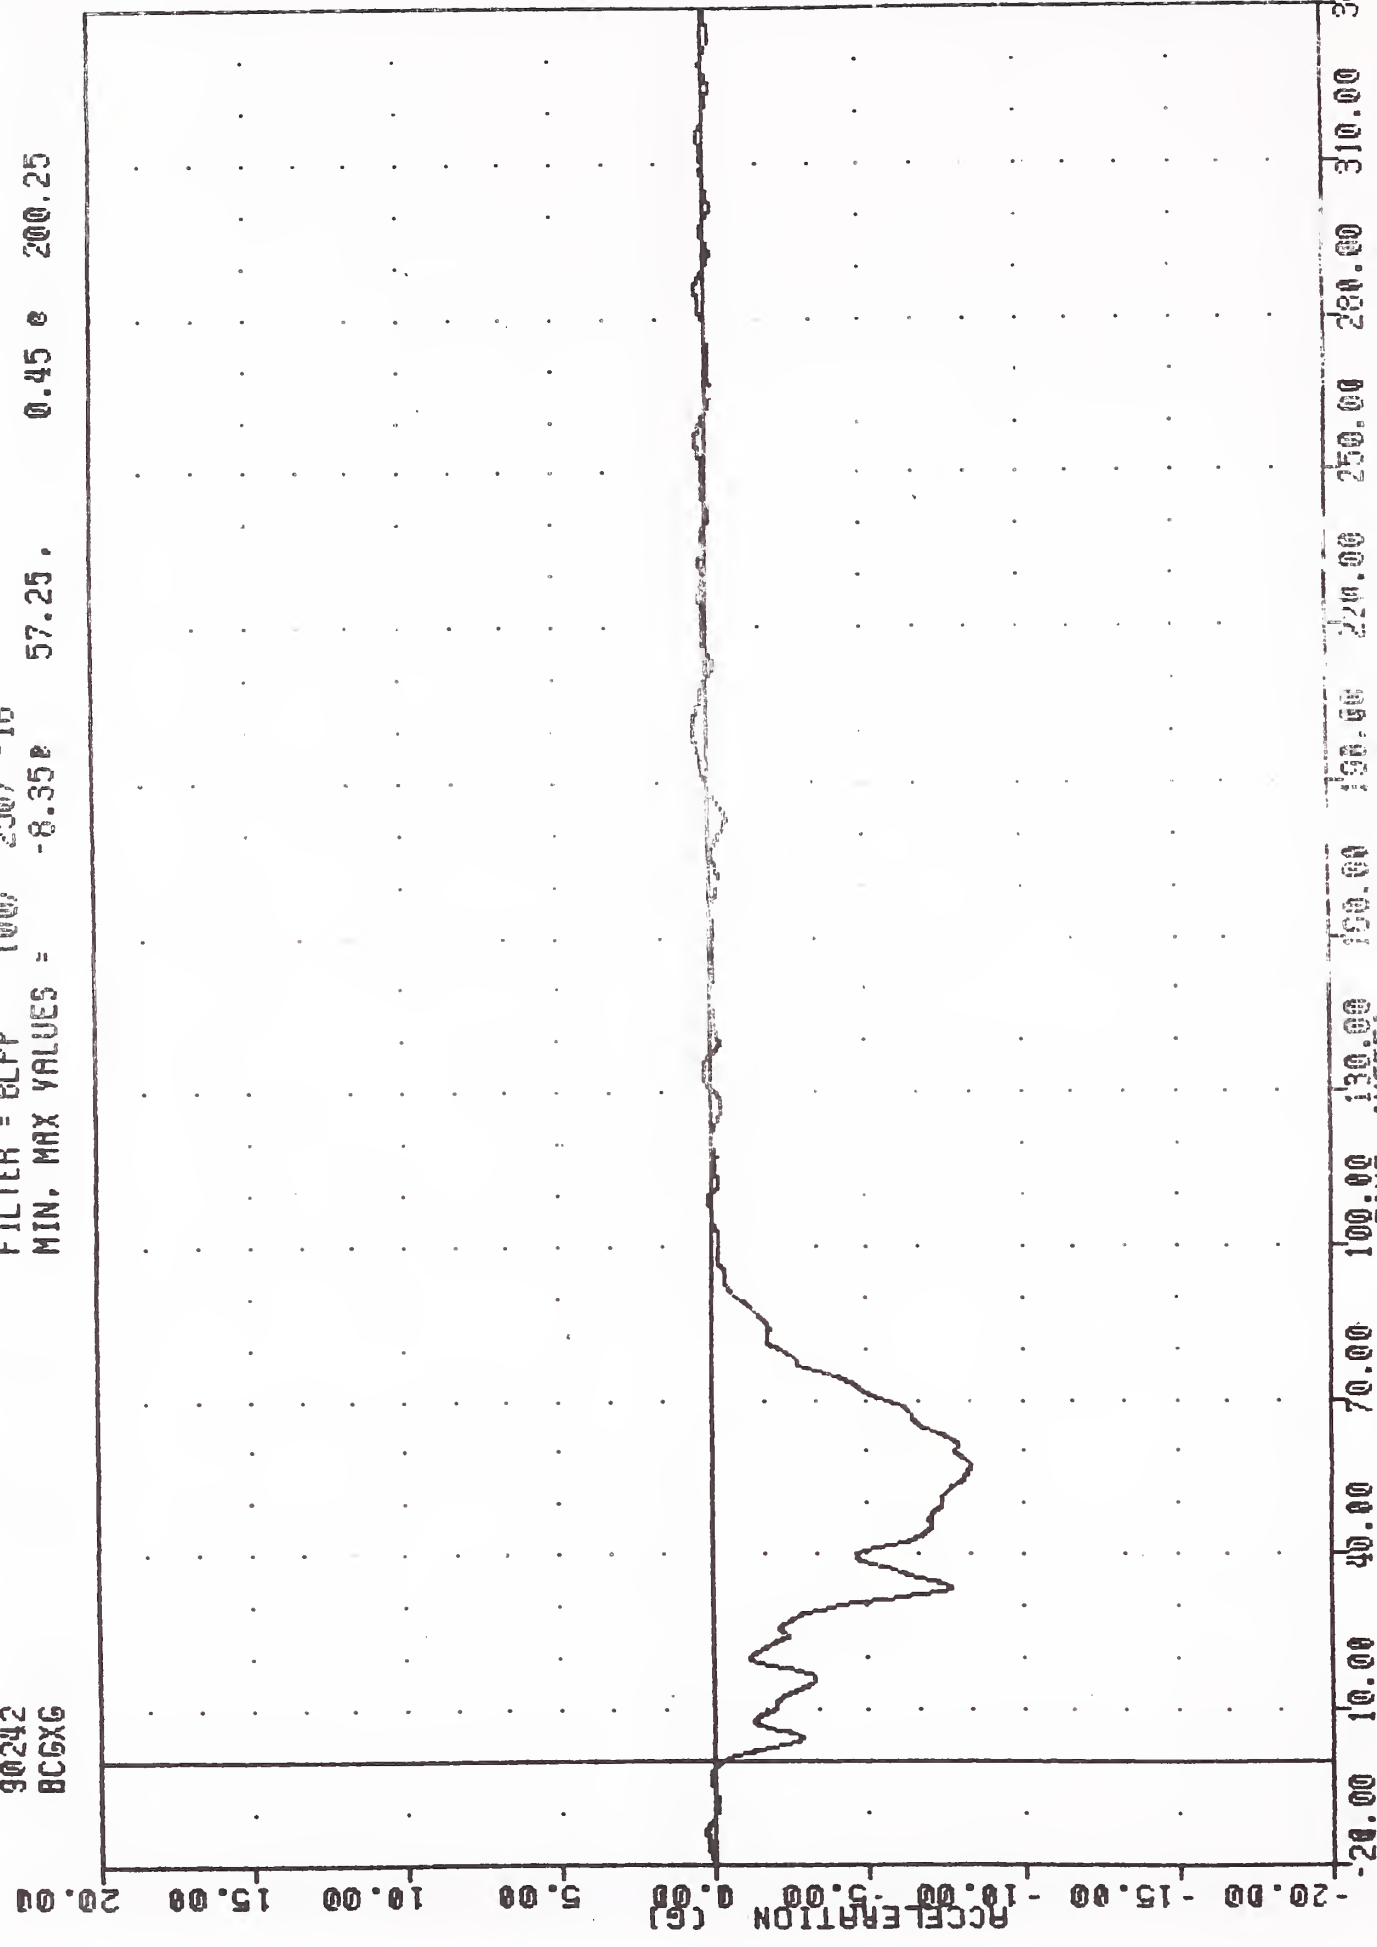
CONTOURED MOVING BARRIER INTO FORD ESCORT AT 14.2 MPH *1
 MOVING BARRIER CENTER OF GRAVITY X-AXIS ACCELERATION

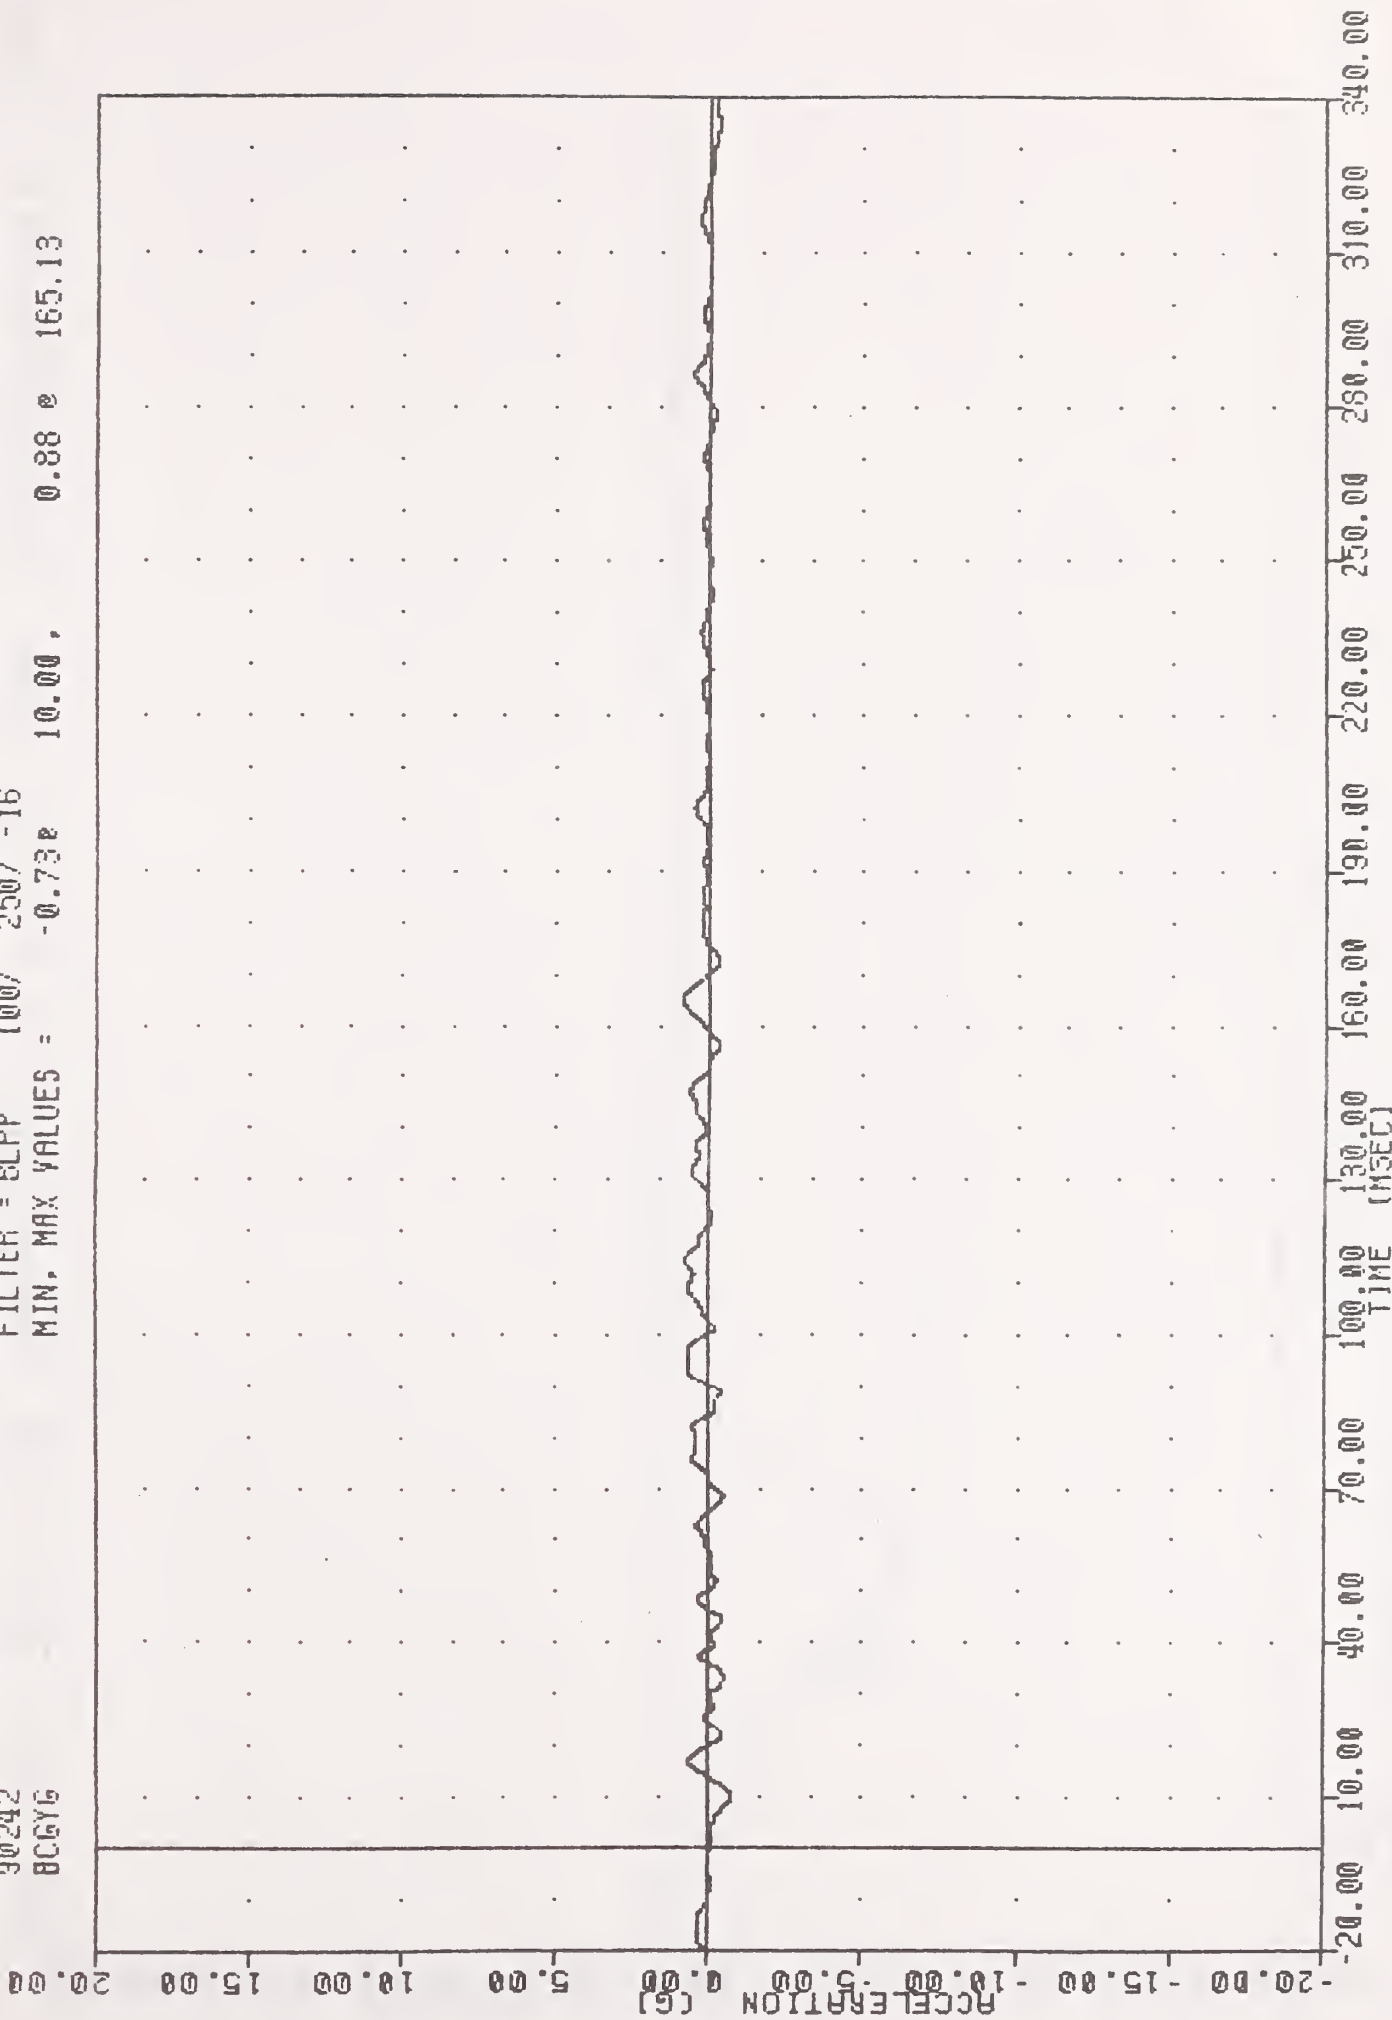
CONTOURED MOVING BARRIER INTO FORD ESCORT AT 14.2 MPH #1
 MOVING BARRIER CENTER OF GRAVITY Y-AXIS ACCELERATION

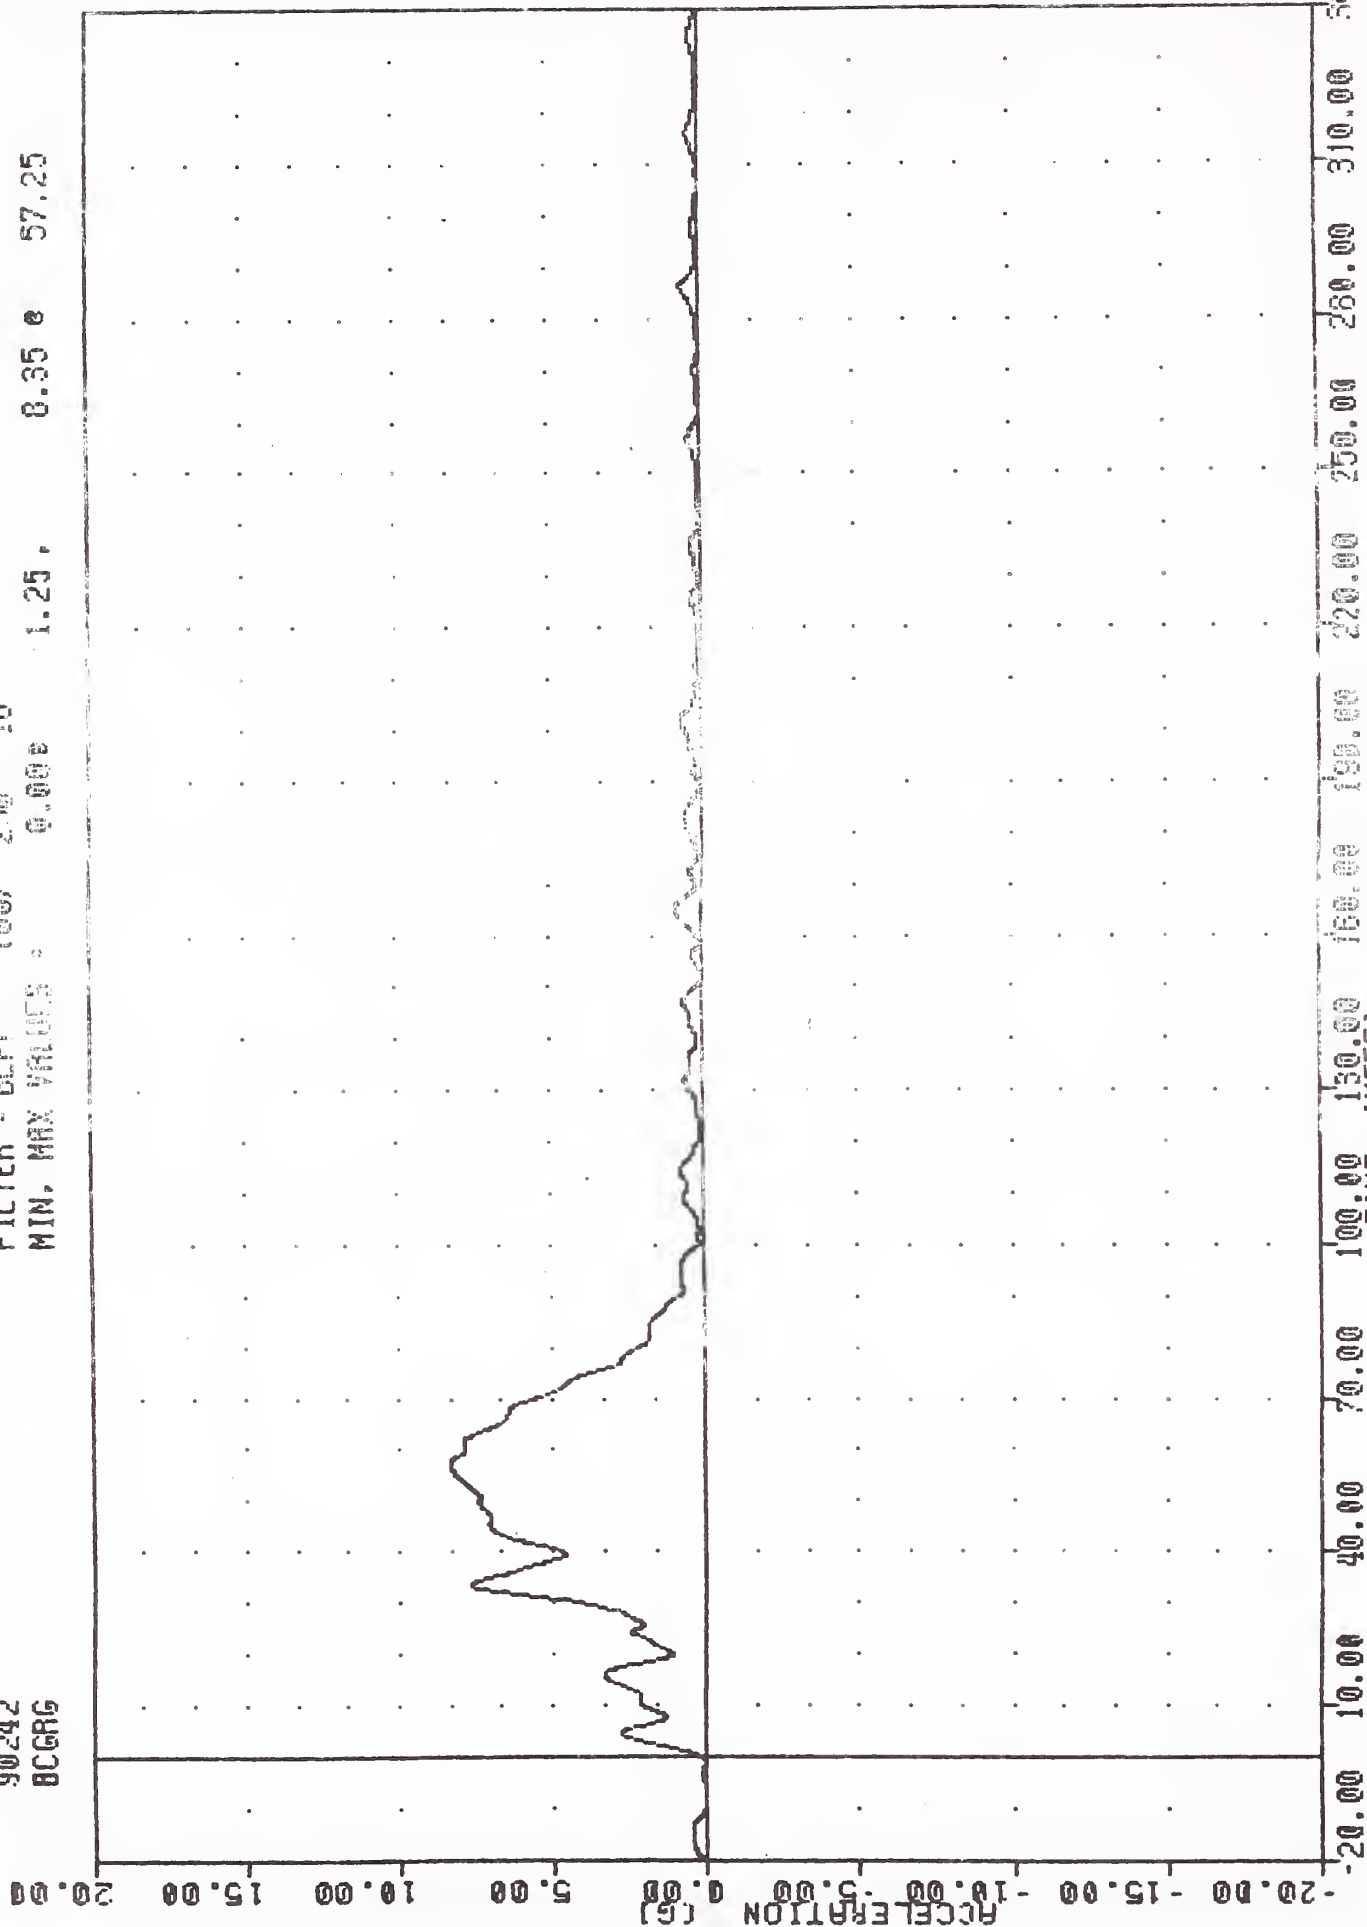
CONTOURED MOVING BARRIER INTO FORD ESCORT AT 14.2 MPH #1
 MOVING BARRIER CENTER OF GRAVITY RESULTANT ACCELERATION

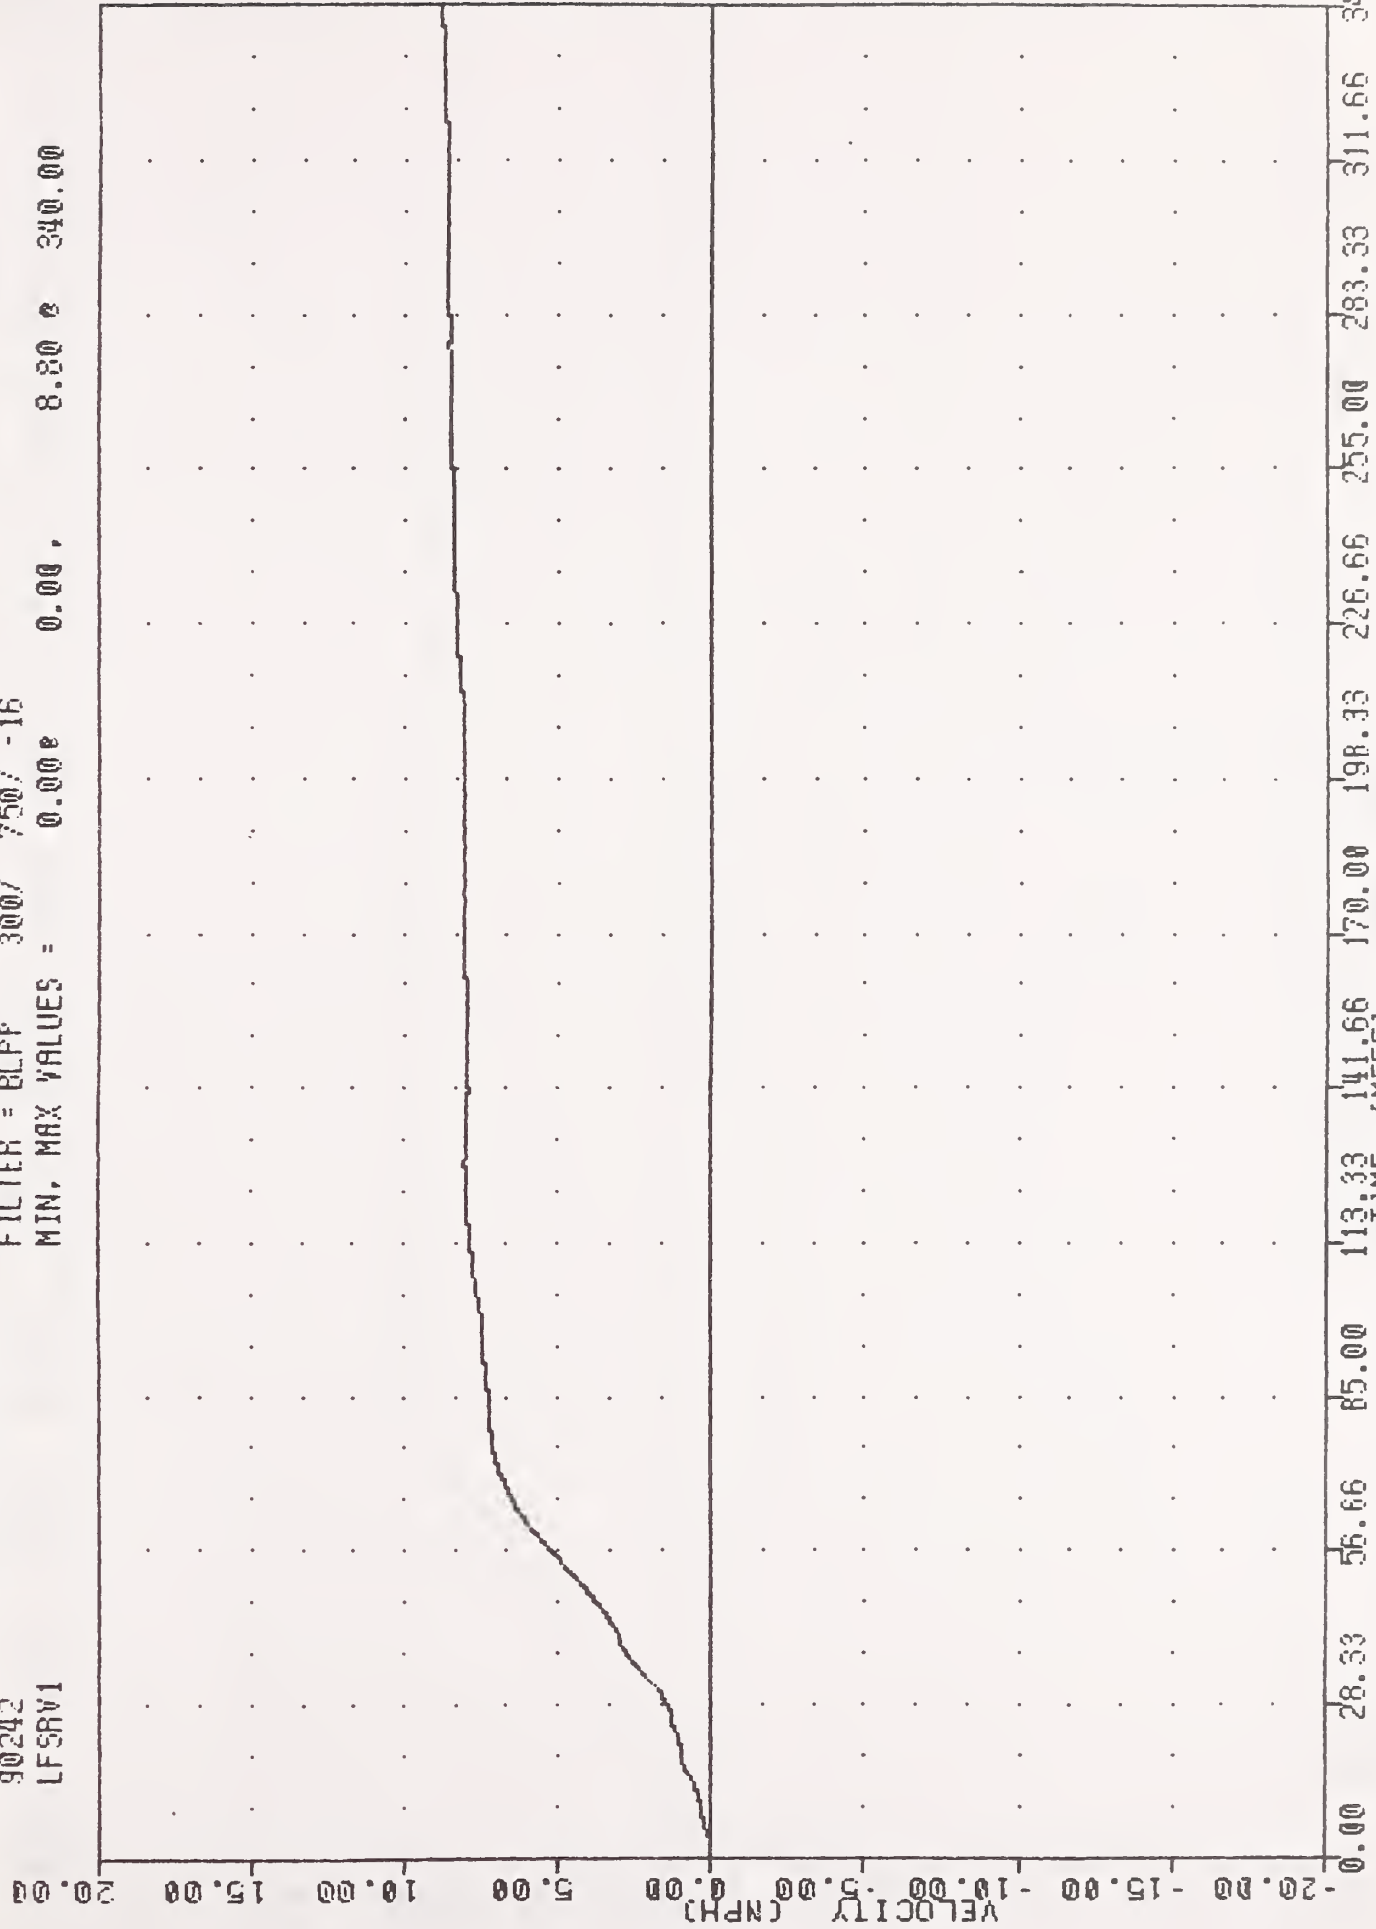
CONTOURED MOVING BARRIER INTO FORD ESCORT AT 14.2 MPH #1
 LEFT FRONT SILL RESULTANT VELOCITY

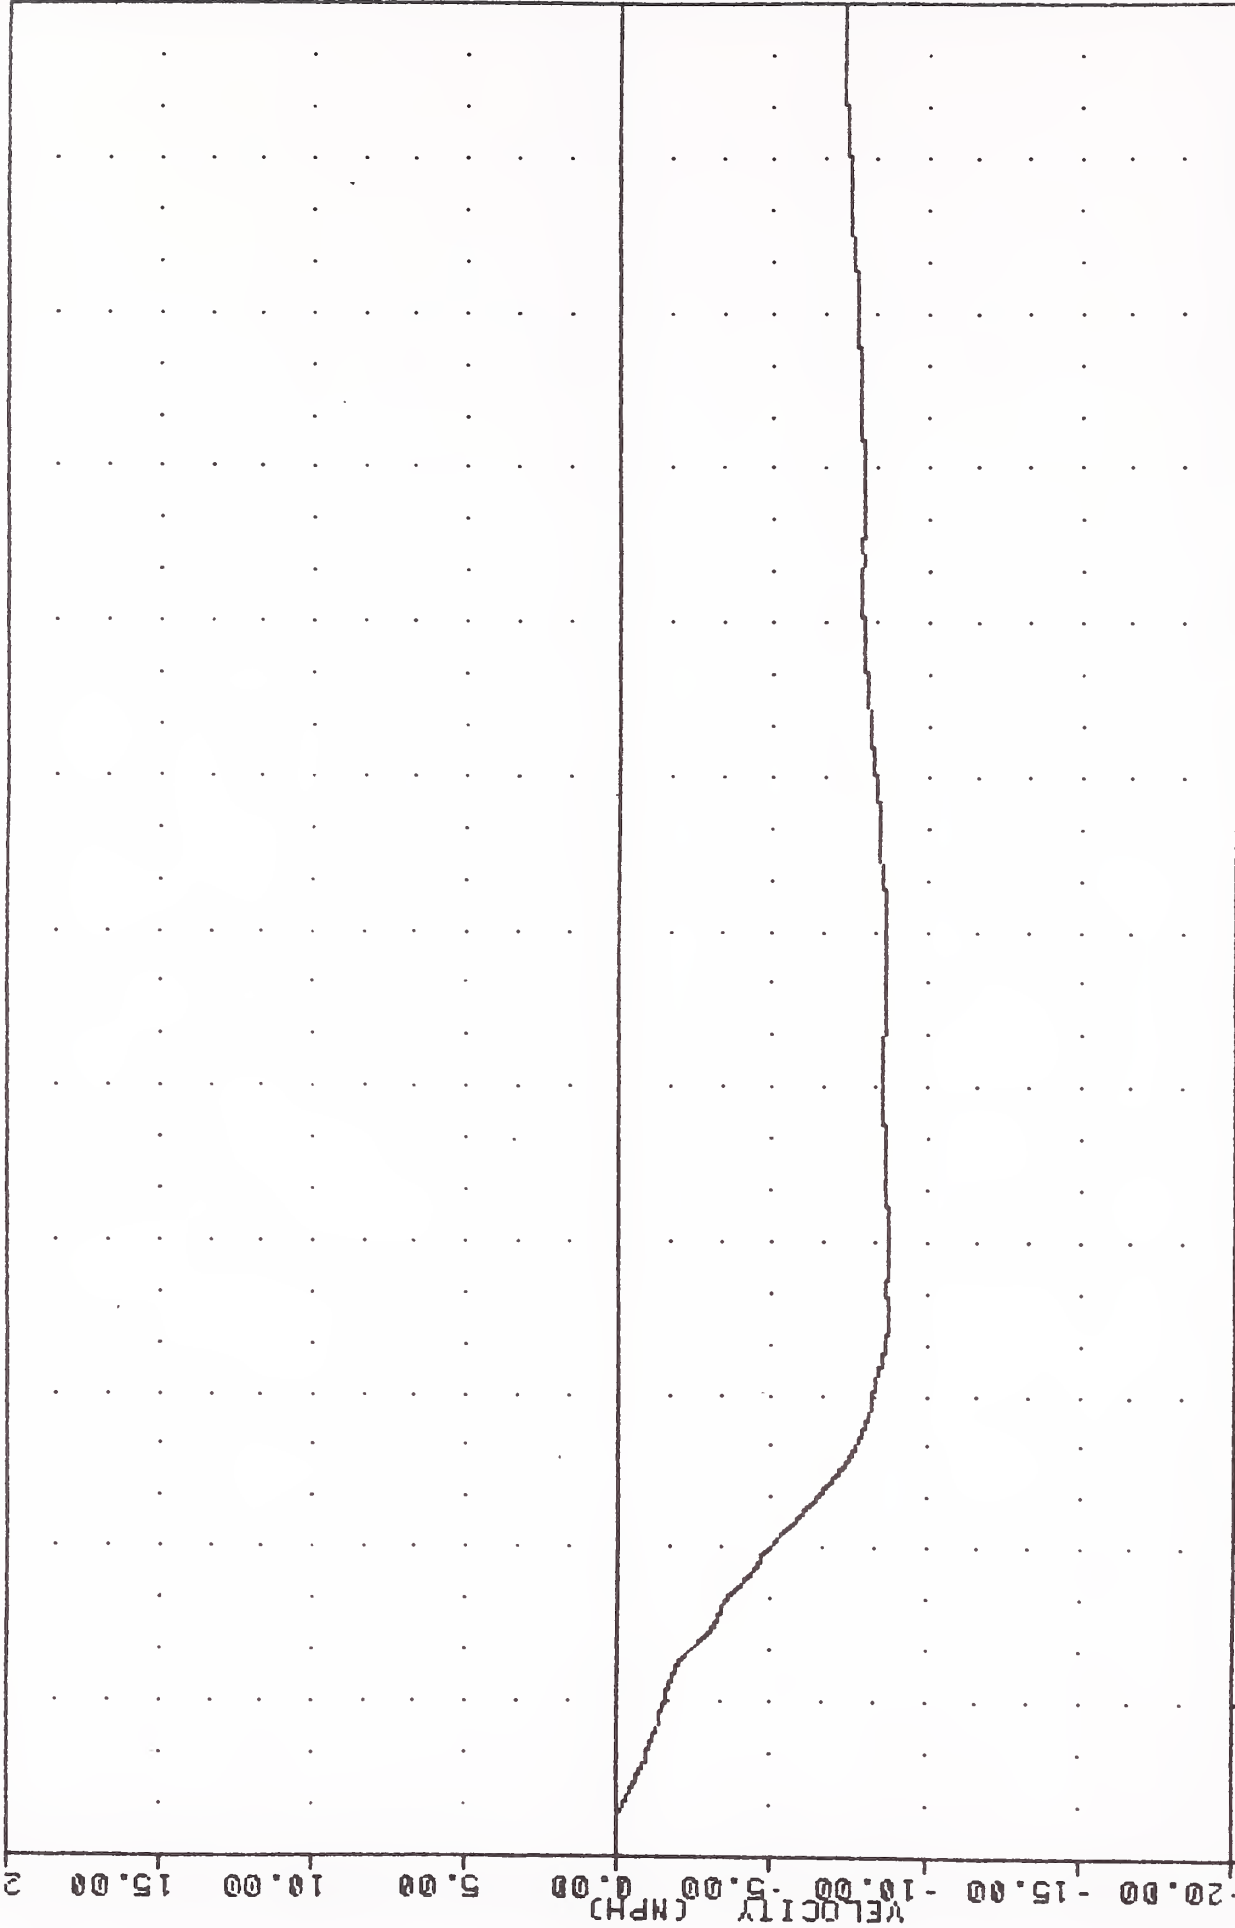
CONTOURED MOVING BARRIER INTO FORD ESCORT AT 14.2 MPH #1
 RIGHT FRONT SILL X-AXIS VELOCITY

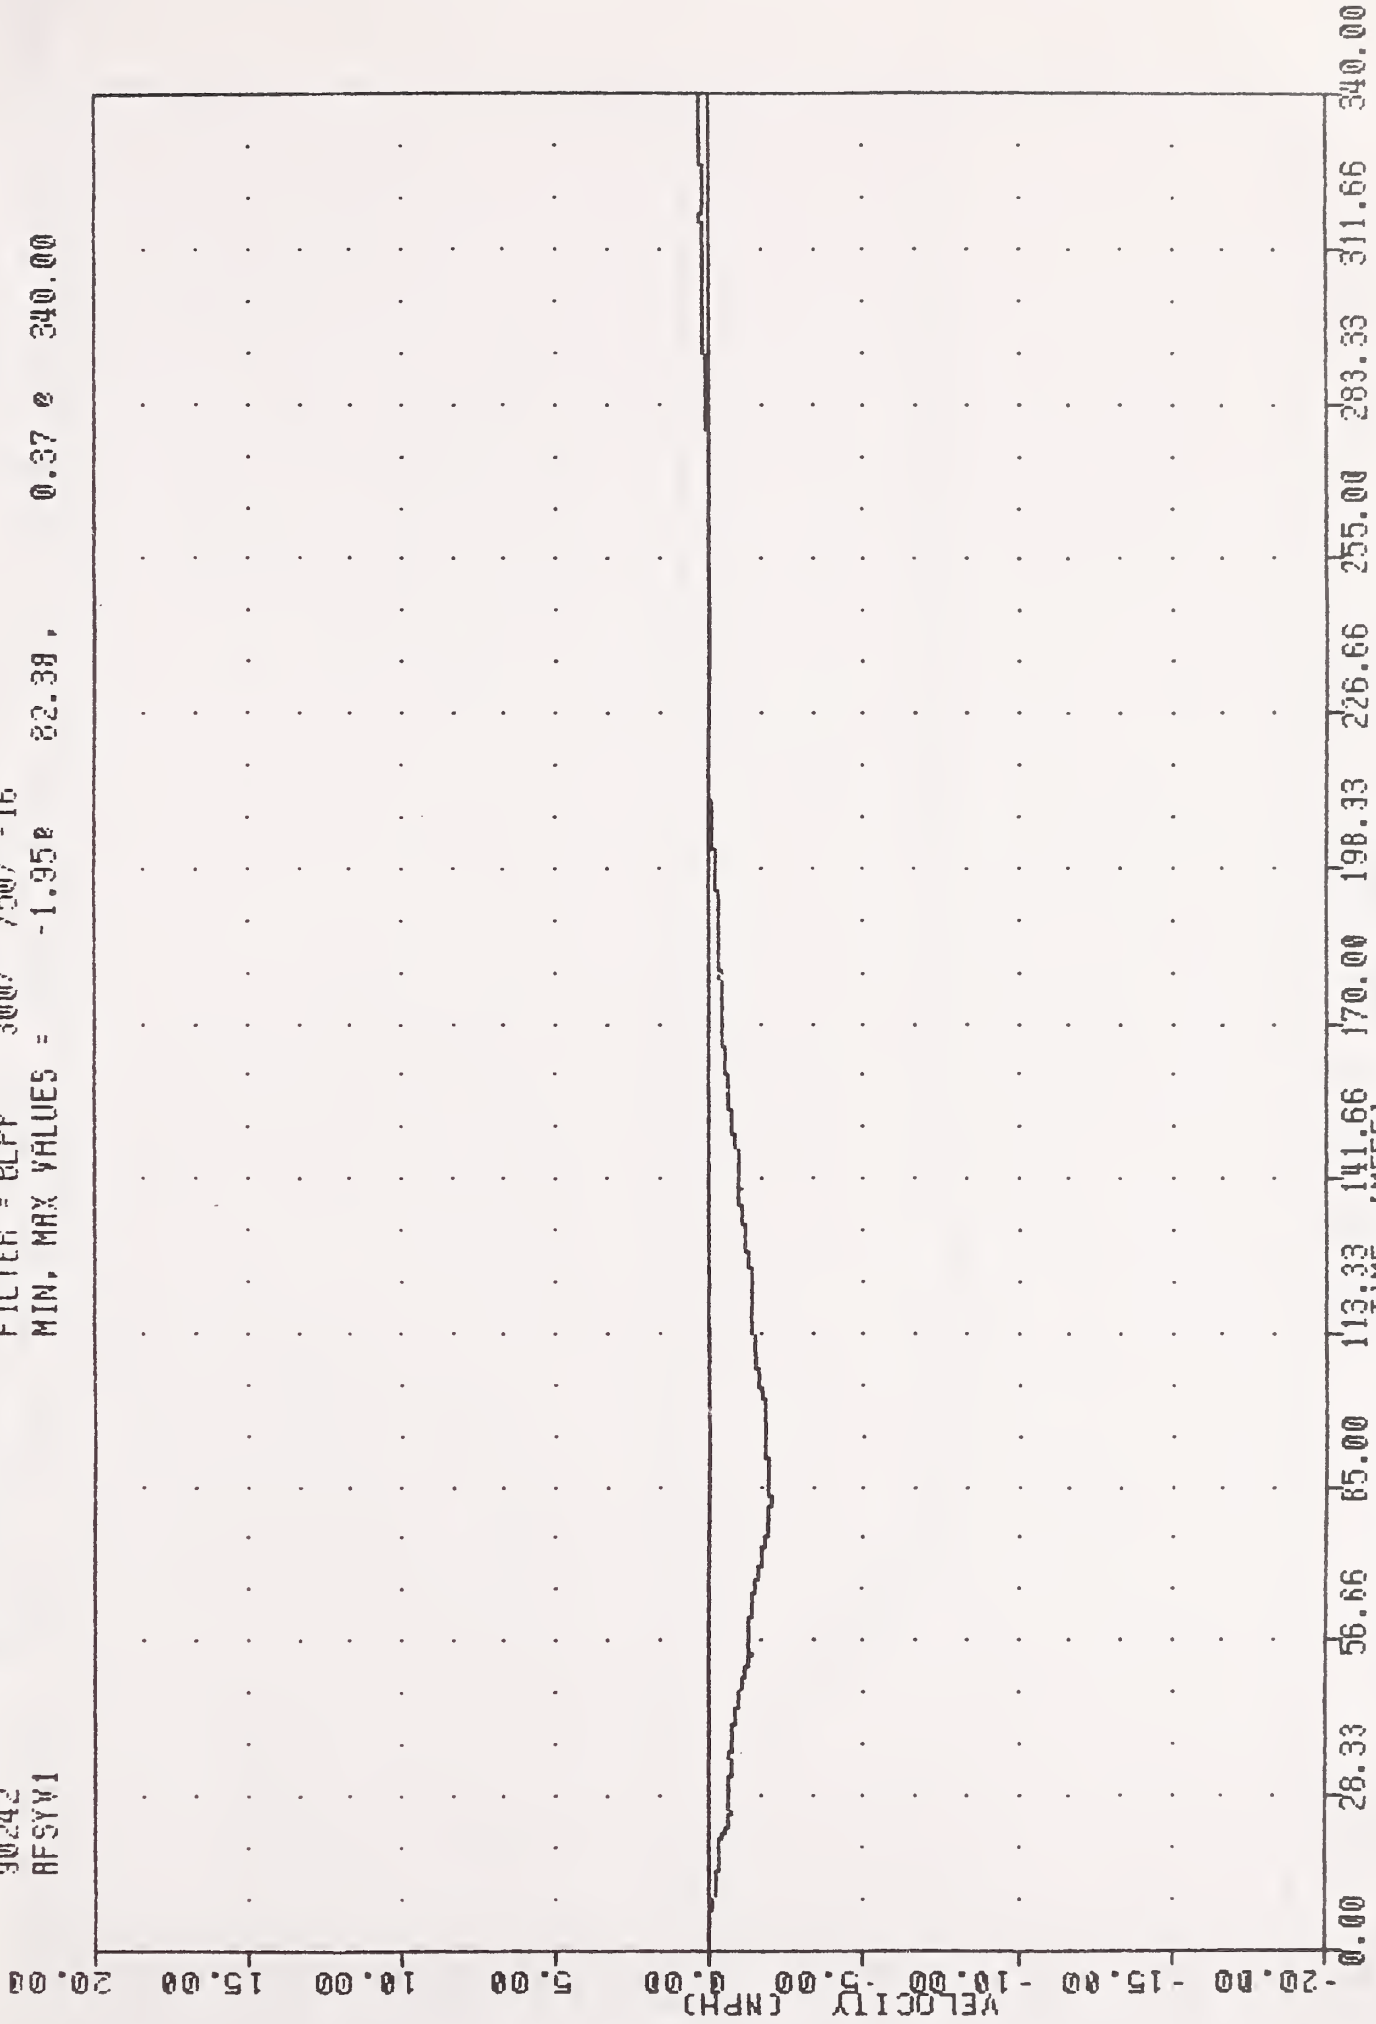
CONTOURED MOVING BARRIER INTO FORD ESCORT AT 14.2 MPH #1
 RIGHT FRONT SILL Y-AXIS VELOCITY

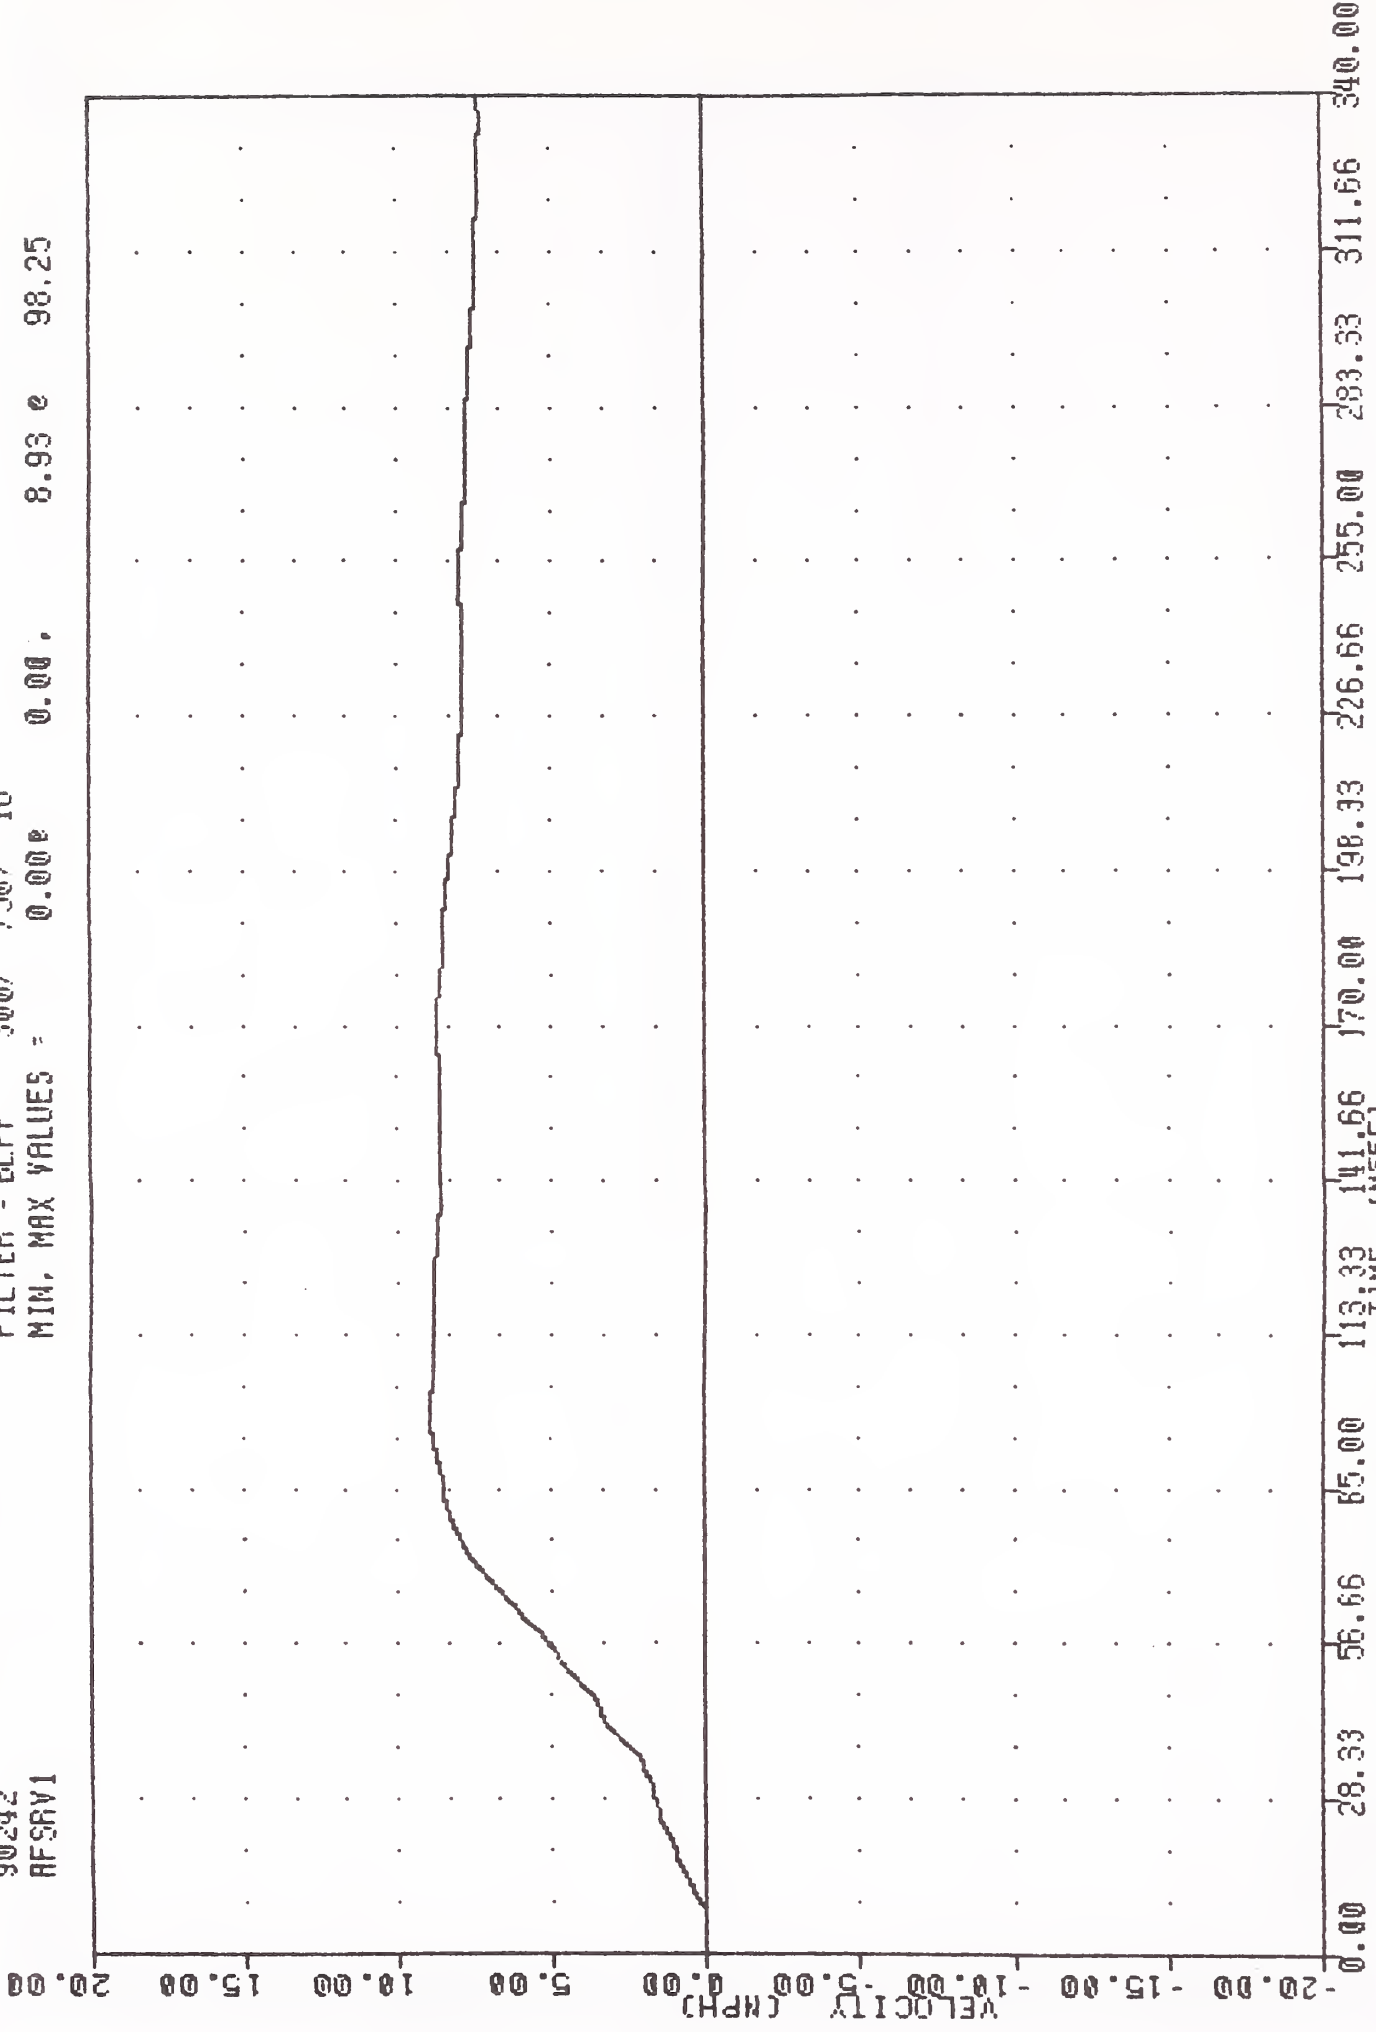
CONTOURED MOVING BARRIER INTO FORD ESCORT AT 14.2 MPH #1
 RIGHT FRONT SILL RESULTANT VELOCITY

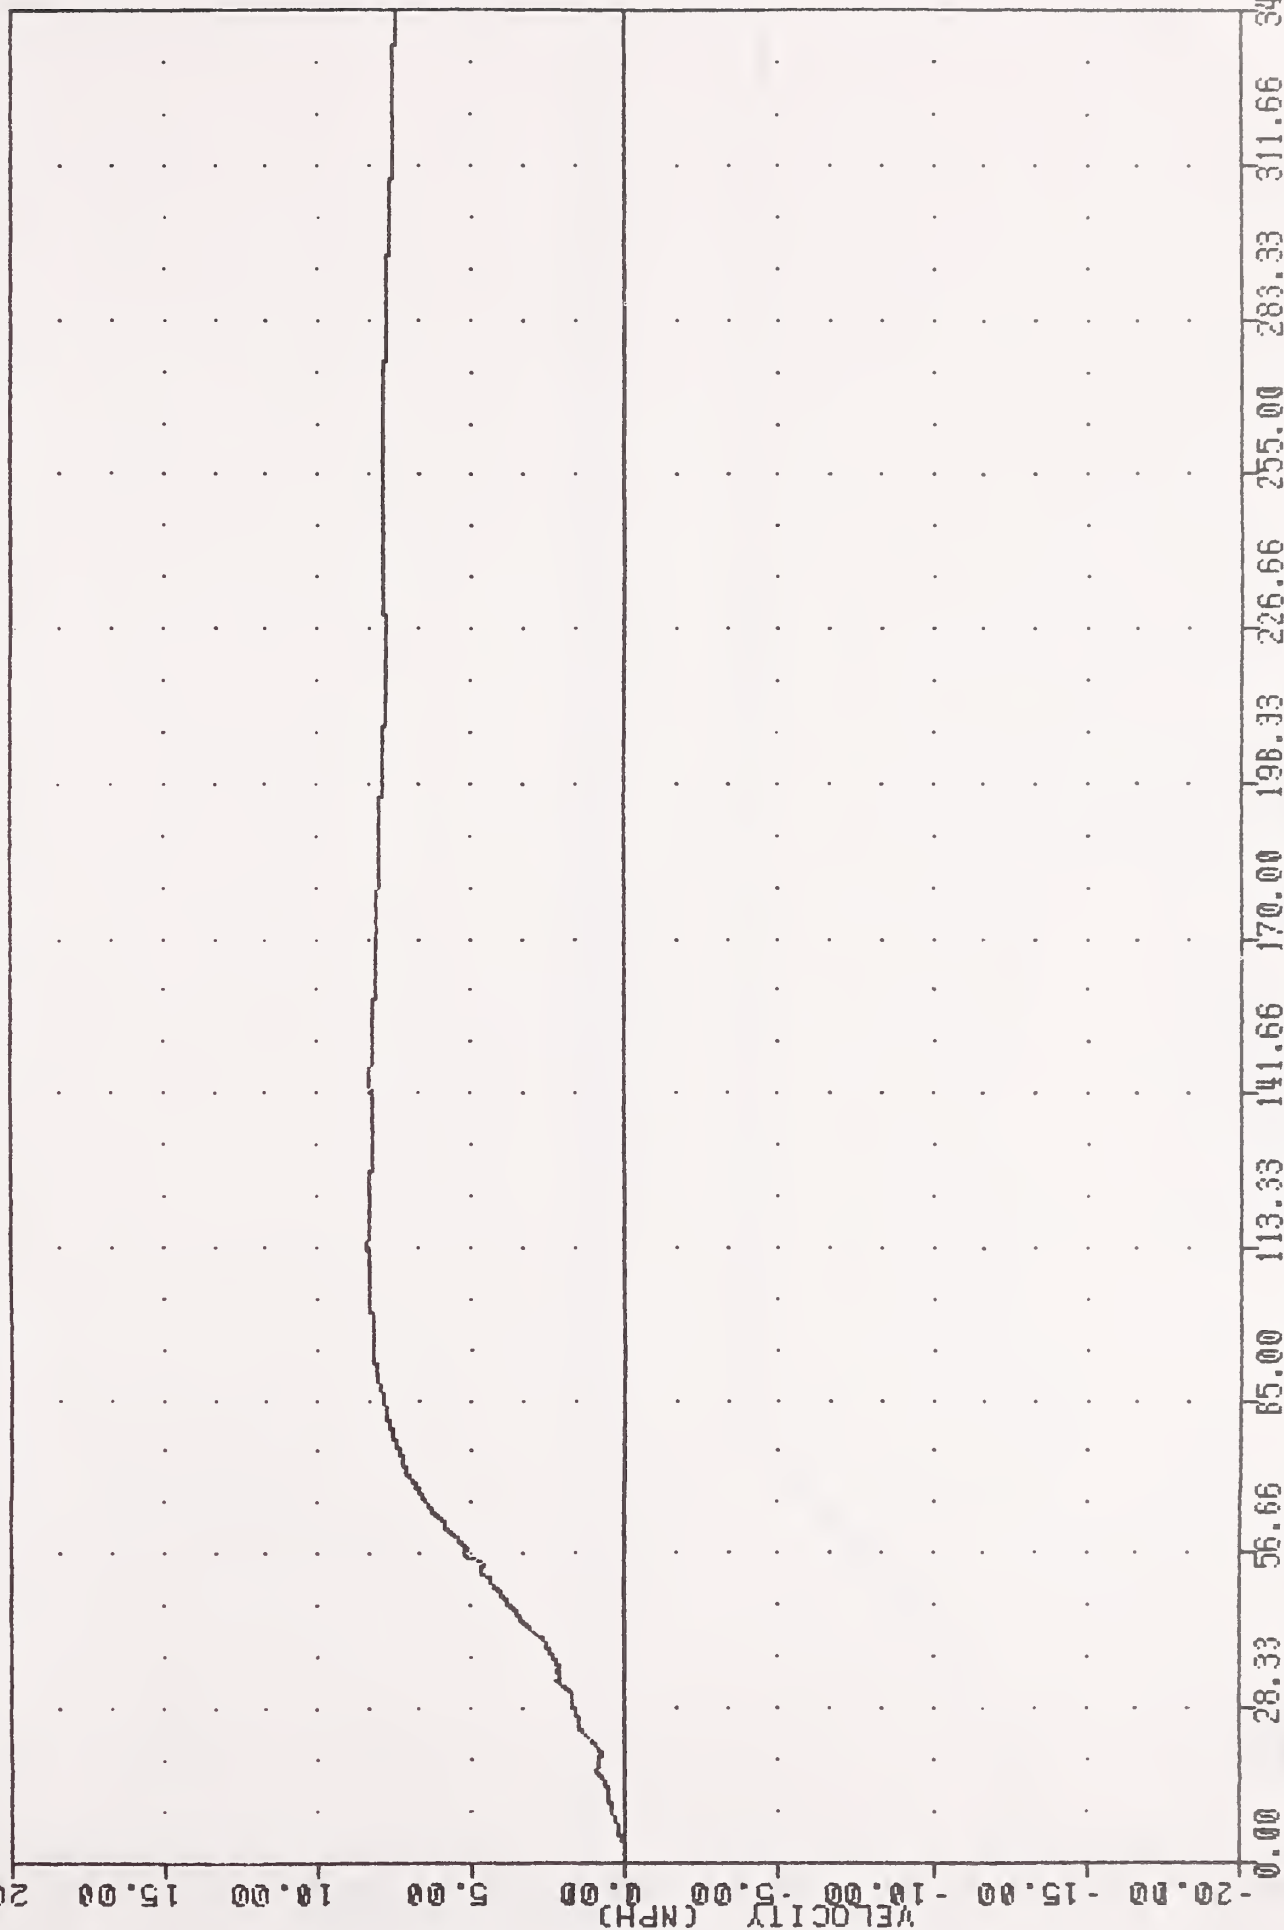
CONTOURED MOVING BARRIER INTO FORD ESCORT AT 14.2 MPH #1
 VEHICLE CG RESULTANT VELOCITY
